Lighthouse Cove Bathymetry Map

Conducted by High Water Pond Management

Date: 6/4/2025

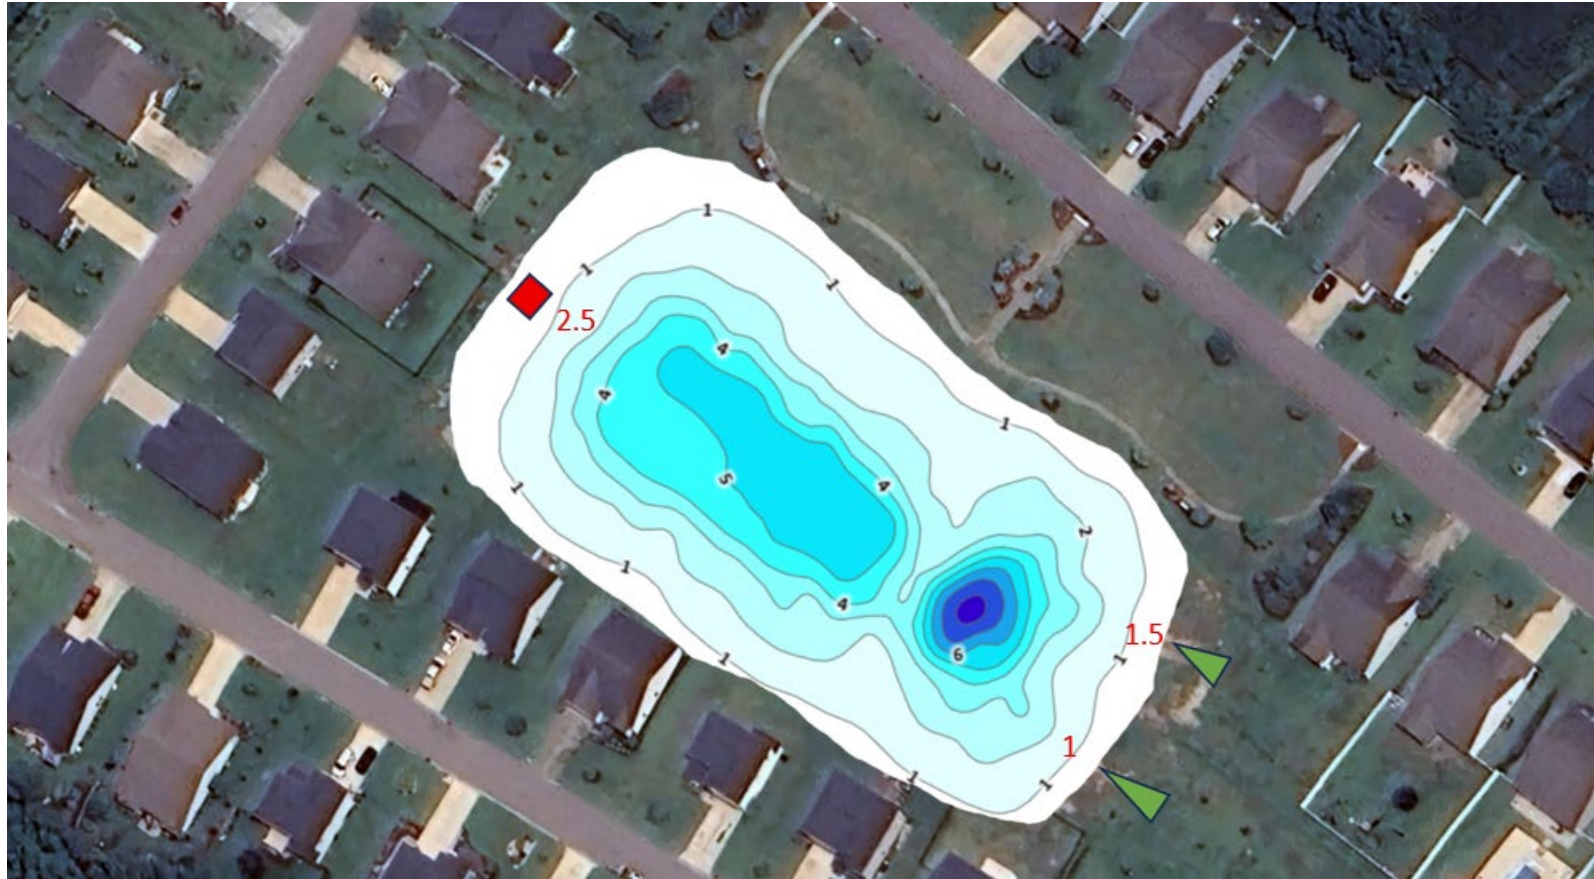
Bathymetry Map

The bathymetry map represents the depth of the stormwater pond. The darker shades of blue indicate an increase in depth. Each contour line represents a one-foot change in depth.

Key Findings: The forebay pool is significantly deeper than the main pool, indicating there has not been significant sedimentation in the forebay pool.

The forebay berm is still present, although the southwest side is significantly lower than the northeast side. Compare with pond as-built to ensure the dimensions are still as designed.

Depth at each inflow is not impacting the functionality.

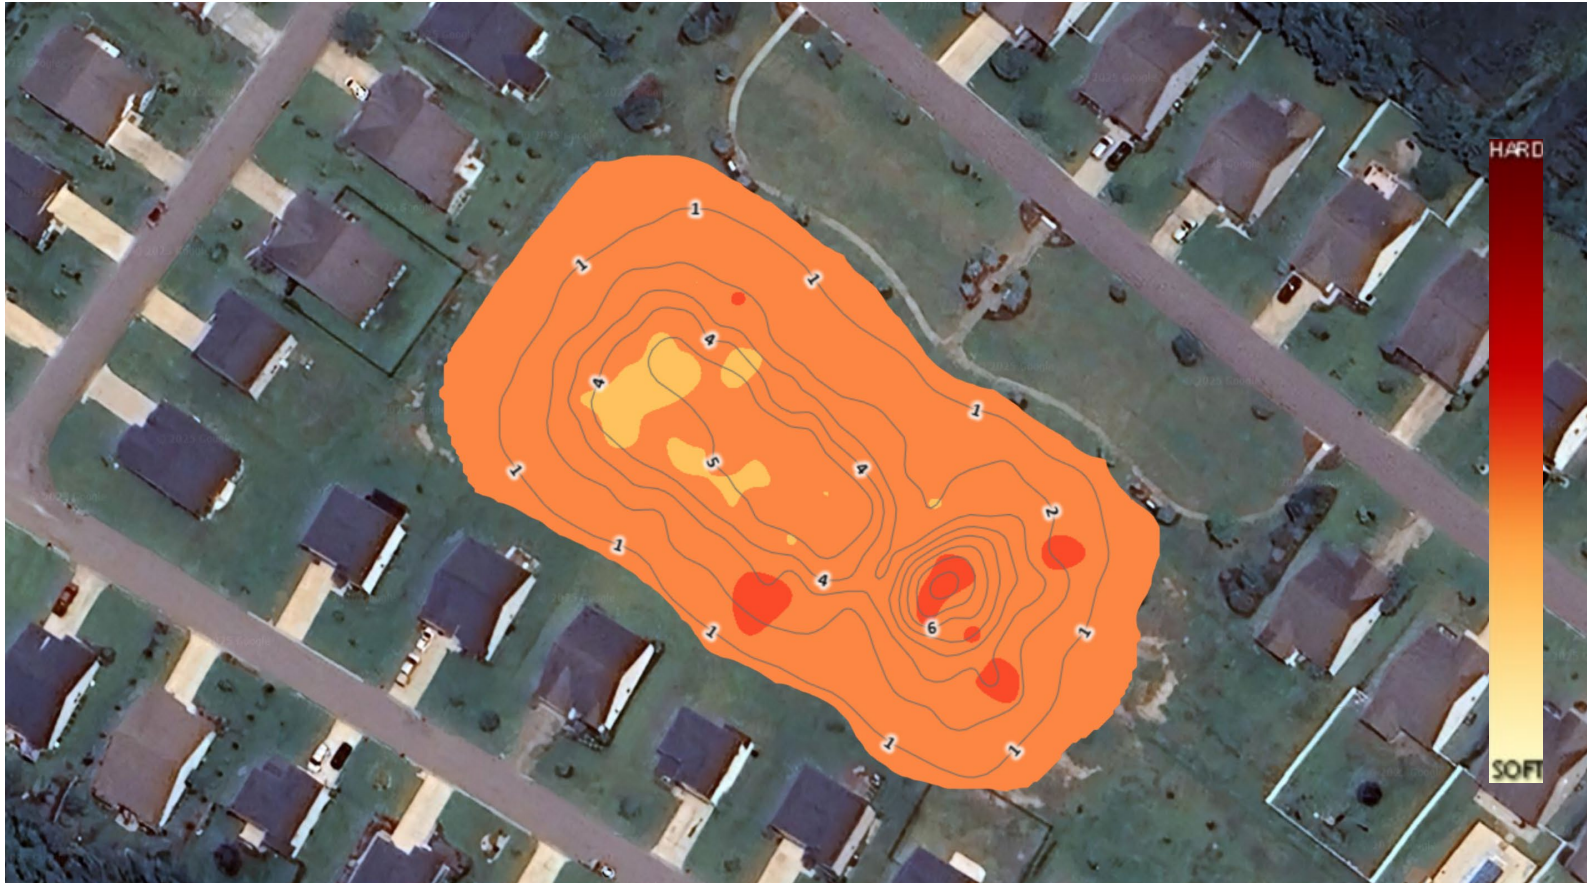
Sedimentation Map

This sedimentation map illustrates the distribution of sediment on the bottom of the pond. The lighter colors indicate a softer bottom. Softer bottom typically indicates sedimentation. Areas with the lightest shade should be monitored for dredging moving forward.

Key Points: The elevated hardness in the forebay around the two inflow pipes is due to the rip-rap aprons below the inflow pipes.

Hardness in the bottom of the forebay indicates low levels of sedimentation in the forebay.

Dredging may be required in the main pool in the future. Monitor and compare with the original depth shown in the as-built.

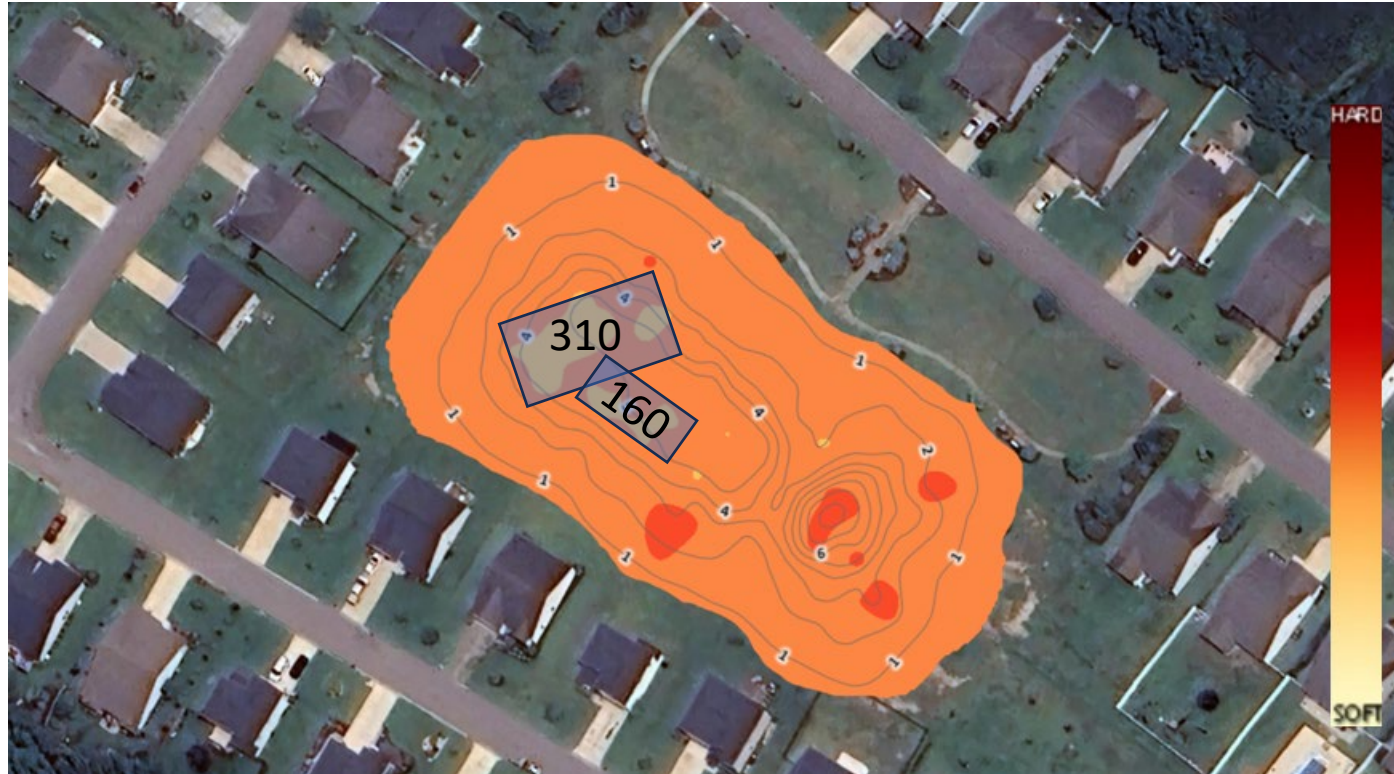
Possible Areas for Dredging

The two areas highlighted in blue represent the two areas that should be monitored for possible dredging in the future. Most of the sediment is collecting at the deepest part of the main pool.

The numbers displayed in the shaded areas represent the approximate number of yards needed to be removed.

With an average sediment depth of a foot and a half, you currently would need to remove approximately 300 cubic yards of material.

The sediment levels should be monitored closely moving forward, comparing the depth described in the as-built to the current depth of the pond. If there are significant differences in the as-built depth vs the actual depth, dredging would be required.

Cost: Removing the current sediment would involve hydraulic dredging. The material would then have to be taken off-site to be disposed of. Current approximation for dredging the stormwater pond ranges from \$30,000-\$50,000
